### 2018-03 – Doleco USA Textile Link Tiedown Assembly

#### Summary

This Inspection Bulletin provides guidance for identifying and inspecting the Doleco USA textile link tiedown assembly (used for cargo securement on trucks or trailers) during a roadside inspection. It also provides guidance for identifying when a defect found within the system qualifies as a violation or an out-of-service condition.

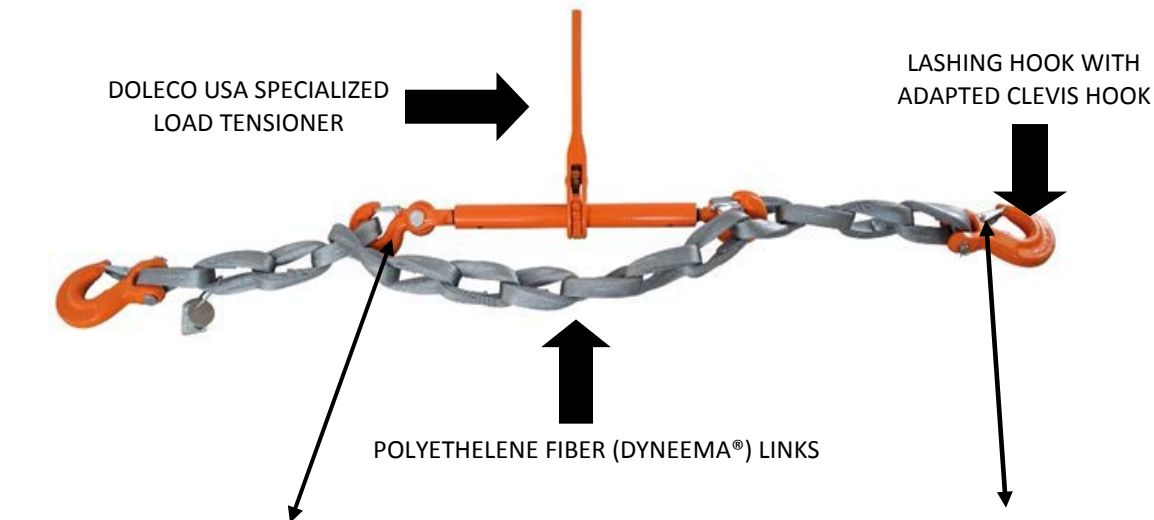
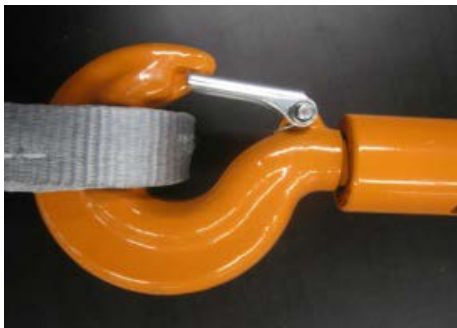
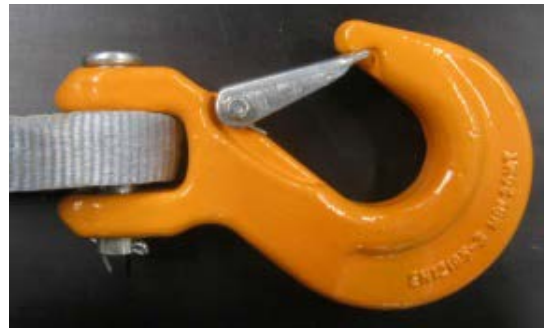
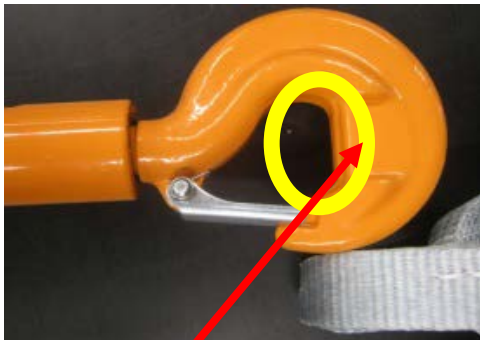
## Linked Webbing System Components and Nomenclature

WIDENED HOOK SUPPORT

The Doleco USA lashing tiedown may only be tensioned and shortened using the Doleco USA special load tensioner Grade 100 (WLL 22,000 lbs. (9,979 kg)) with a specially developed widened hook support. The lashing hook with the adapted clevis hook mount has likewise been developed for the special shape of the textile link. Other fittings may not be used. The tiedown assembly can only attain the manufacturer's WLL if all the components are used together. (NOTE: Utilizing the lashing in a choker hitch – as shown on this page – reduces the WLL by 20 percent)

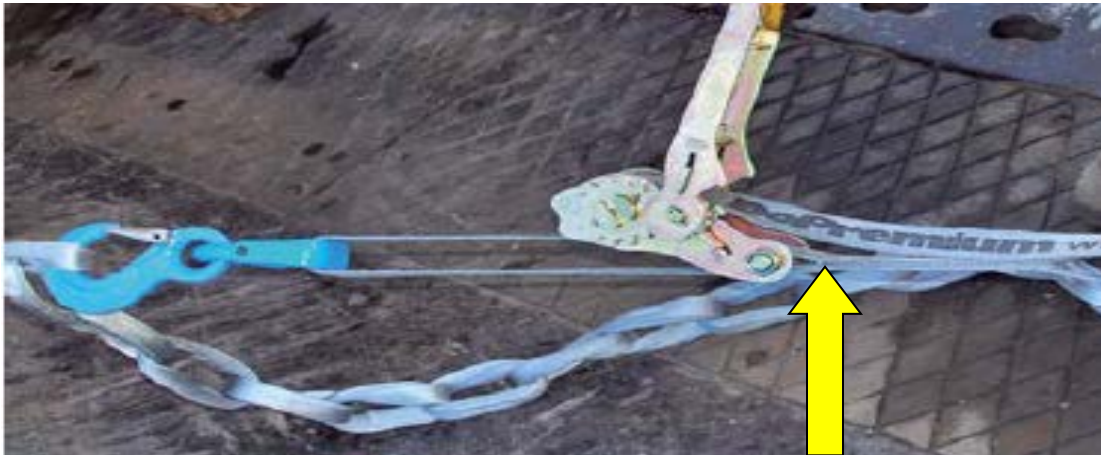
The textile lashing chain may also be combined with connecting elements or end fittings from other Doleco USA lashing systems.

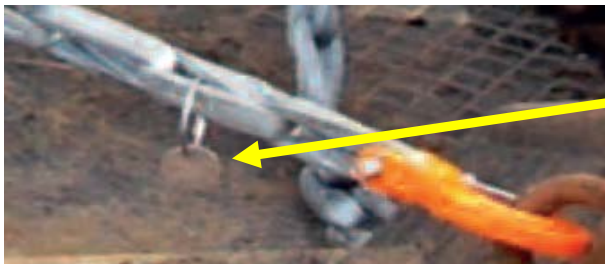
The WLL of 22,000 lbs. (9,979 kg) for the tiedown assembly is marked by the manufacturer with a metal tag attached by a small cable to the assembly. The tiedown assembly will be afforded this WLL provided the tag is present.

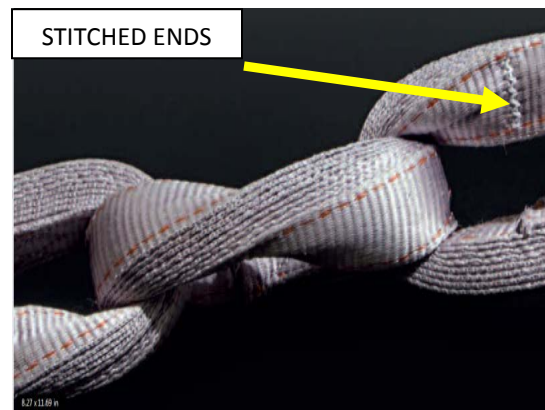
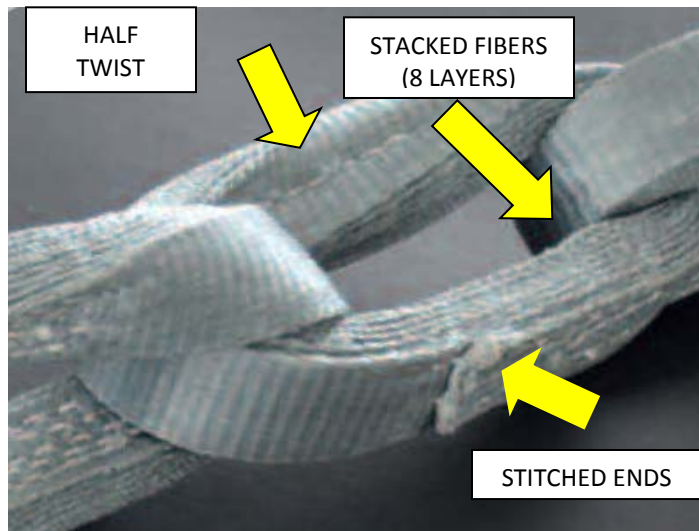
The links are made by weaving narrow polyethelene (Dyneema®) fibers, stacking the resulting fabrics into eight-layer links and stitching the end connections with Dyneema® yarn. Each link contains a half twist and therefore has no real inner or outer side. This results in an even loading of the layers. The performance of such a shaped winding link is considerably higher than that of similar multi-layer winding where the layers are simply placed above one another.

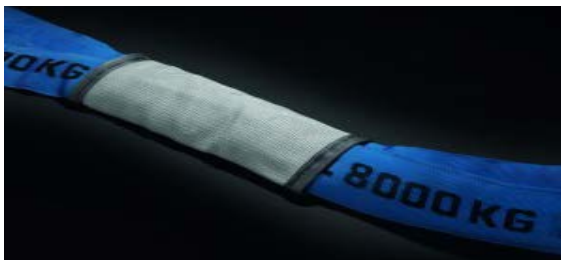
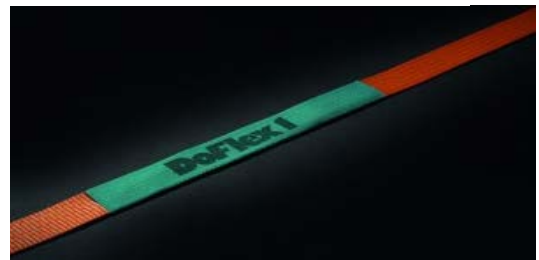
#### MANUFACTURER-PRODUCED EDGE PROTECTION

As per the manufacturer, the textile links may only be used with loads containing sharp edges and rough surfaces if the endangered points are protected (e.g., the DoAntiCut® protective sleeve made of UHMW-PE).

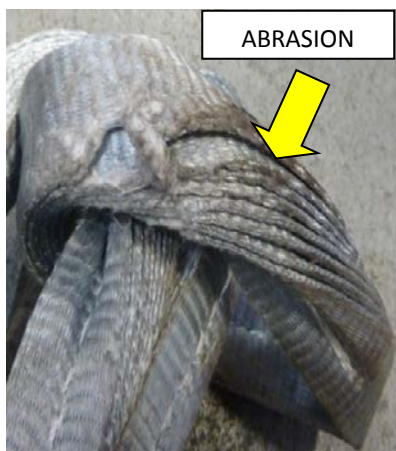
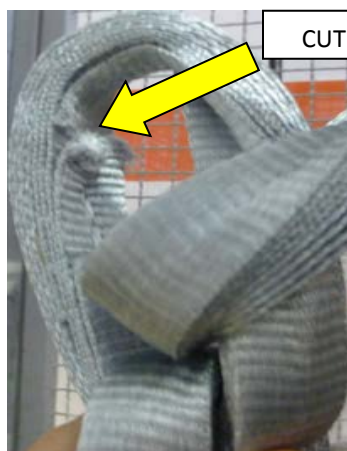
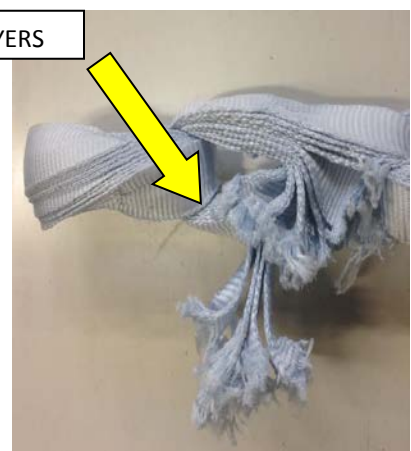
- Tiedowns shall not be loose.
- Tiedowns must not be knotted.
- A fitting, tensioning device or other hardware (other than webbing) shall not be broken, obviously sprung, bent, twisted, or contain a visible crack, significant nick or gouge.
- Tensioning and connecting elements must not be loaded to the point of bending.
- Links shall not be deformed due to heat (friction, radiation).
- Lashing hooks must be loaded in the hook bowl (see lashing hook with the adapted clevis hook mount). Links may not be loaded on a hook tip.
- The hook mouth must not be widened by 5 percent or more.
- Links shall not contain cut layers and severe abrasions.

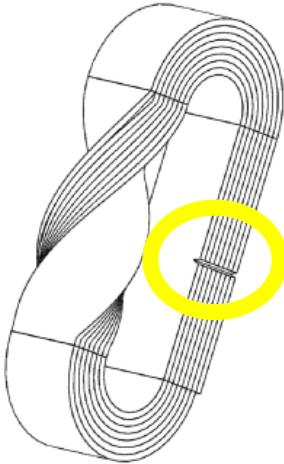
TRANSVERSE

- Links shall not have more than one 10 percent transverse or longitudinal cut.

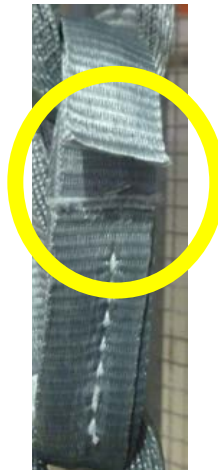
- Links shall not have one ply (or more) cut through - inside or outside.

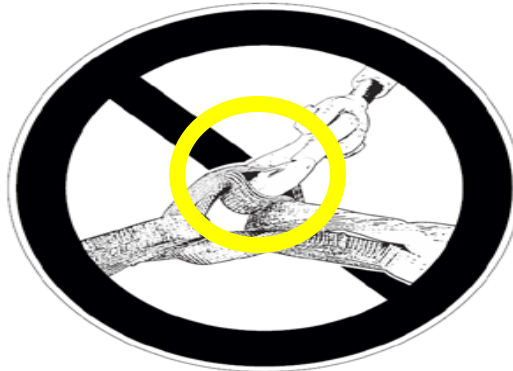
- The hook shall not be hooked in between the plies.

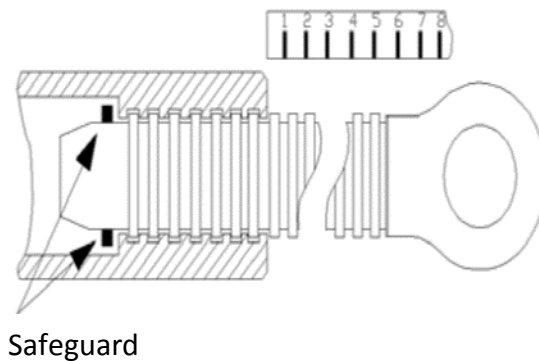
- Links shall not contain repairs to damaged ply.
- The unscrewing safeguard of the load binder must not be disabled or damaged (see below).

The special load tensioner is equipped with an unscrewing safeguard.

The unscrewing safeguard of this tensioner consists of a bolt at the end of the spindle arm that stops against the internal thread of the guide tube as soon as the maximum unscrewing length has been reached. Overturning of this safeguard is possible only with the use of extreme force and is noticeable in all cases. If the safeguard is overturned, the bolt cuts into the internal thread of the guide tube and destroys it.
